A 47 year old female patient came to the dental office complaining pain and swelling on upper right lateral incisor and mobility of the prosthetic crown on it.

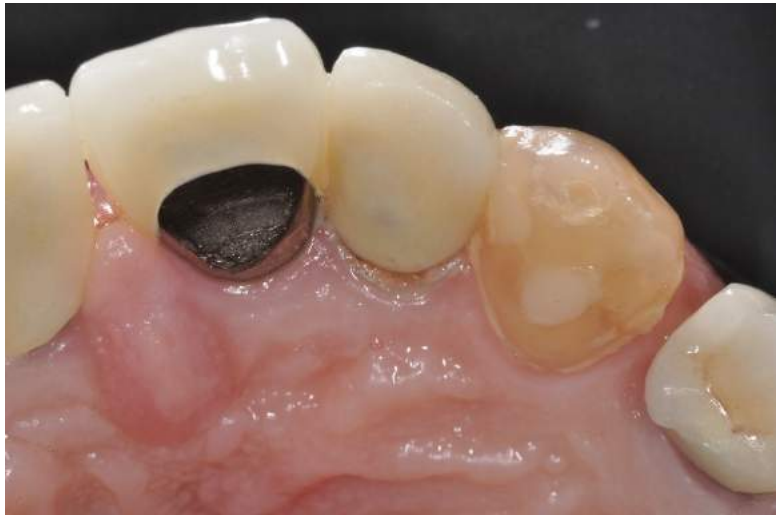
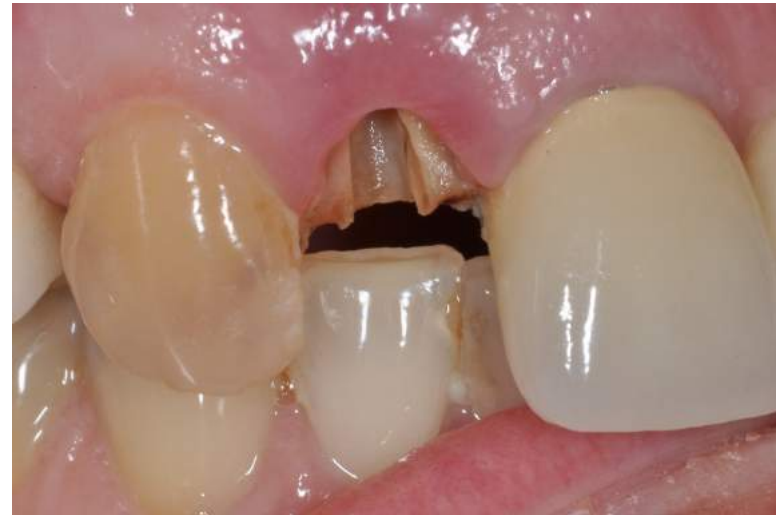
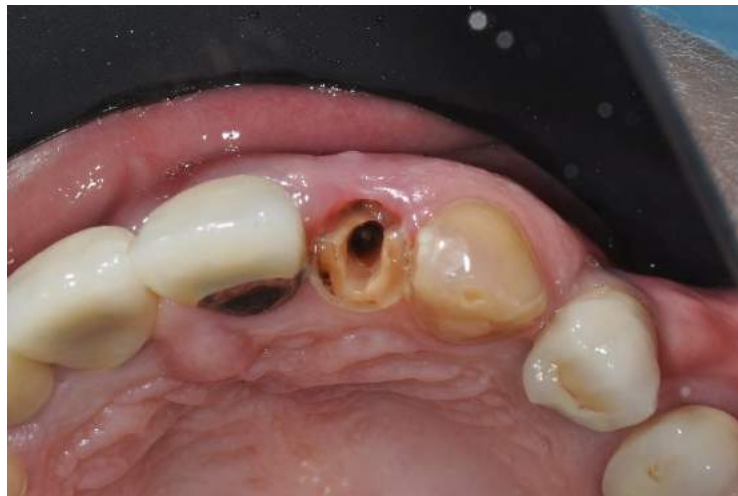
Inspection showed the presence of vestibular fistula with about 9 mm periodontal probing. A deep vestibular root fracture was then diagnosed.

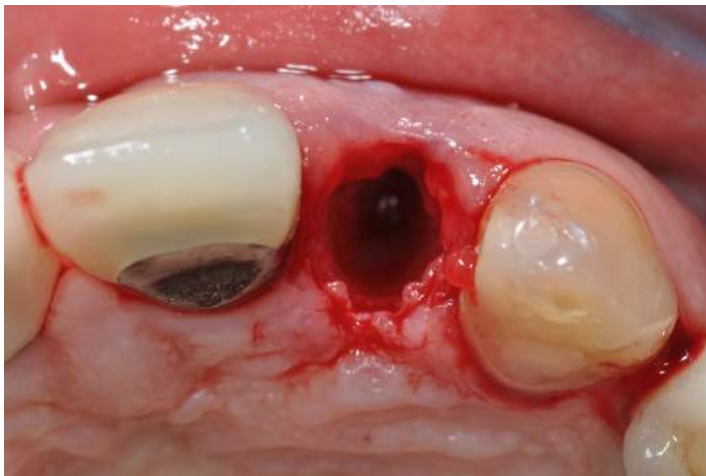
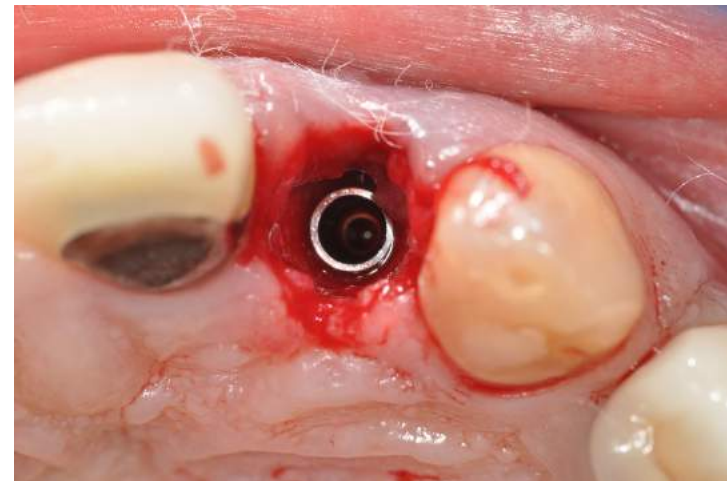
The tooth was extracted and immediately replaced with a 2,75x15mm JDIcon Ultra-S implant

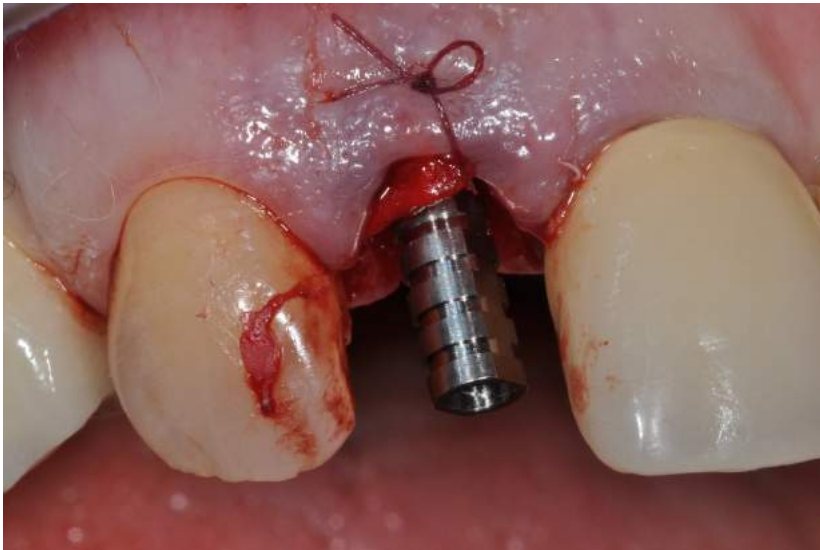
A temporary abutment was immediately attached to the implant.

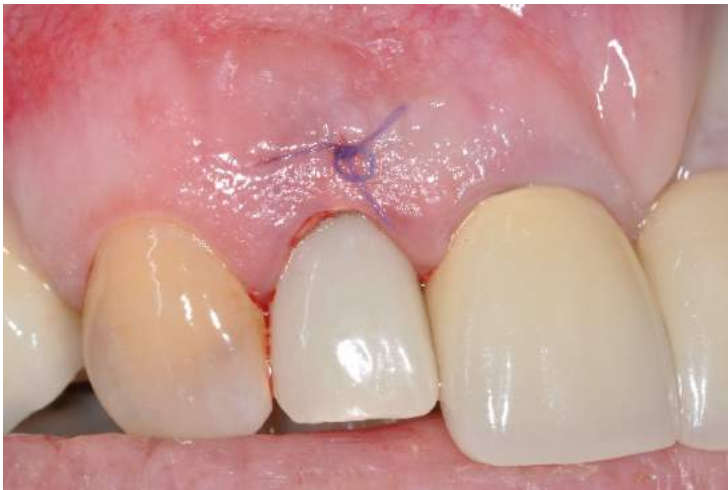
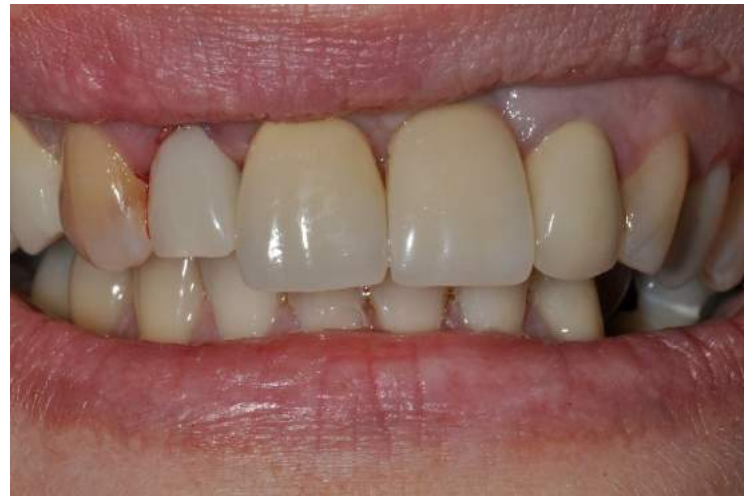
A not functionally loaded screw-retained temporary crown was placed.
